BOWL SEAL REPLACEMENT GUIDE

BOWL SEAL ASSEMBLY INSTALLATION

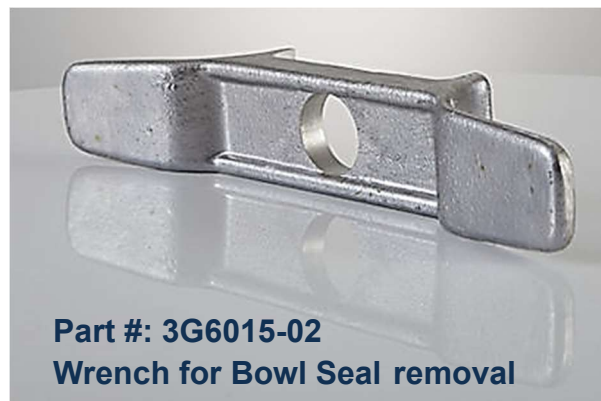
Figure 1:

1. Disconnect unit from electrical power supply
2. Remove knife shaft of knead/mix shaft from bowl
3. Use wrench (figure 1) to remove existing seal
Make sure bowl threads and seal area are cleaned and free of any foreign material

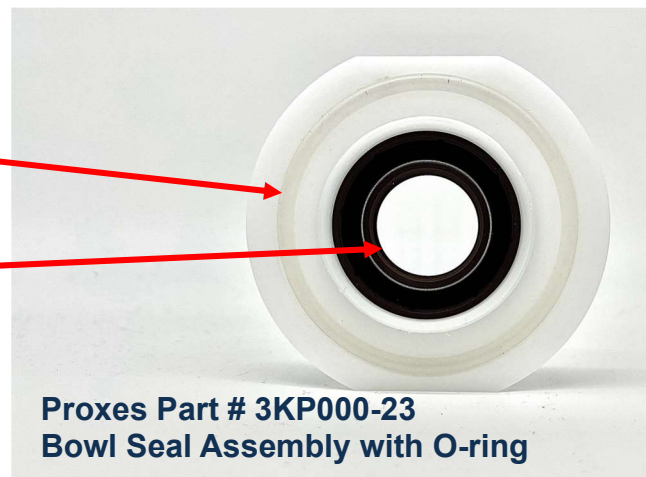
Figure 2:

4. To prepare the new seal for installation, cover the exposed are of the “O” ring (1 of Figure 2) with a liberal amount of lubricant

Next, fill the seal cavity (2 of Figure 2) with a liberal amount of lubricant

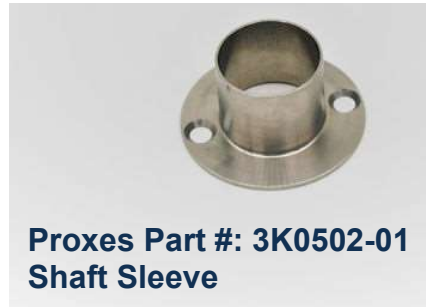
Figure 3:

5. Before installing the new seal, inspect the motor shaft sleeve at the bottom of the bowl (Figure 3) in the seal assembly area for wear/grooves or build-up of foreign material. Clean or replace if necessary

Apply a coat of lubricant to the entire surface of the shaft sleeve (referenced in Step 4)
